WETLANDS OF THE CRESTED BUTTE REGION

MAPPING
FUNCTIONAL EVALUATION
HYDROLOGIC REGIME

David J. Cooper, Ph.D. Ecologist
3803 Silver Plume Circle
Boulder, CO 80303

March 1993

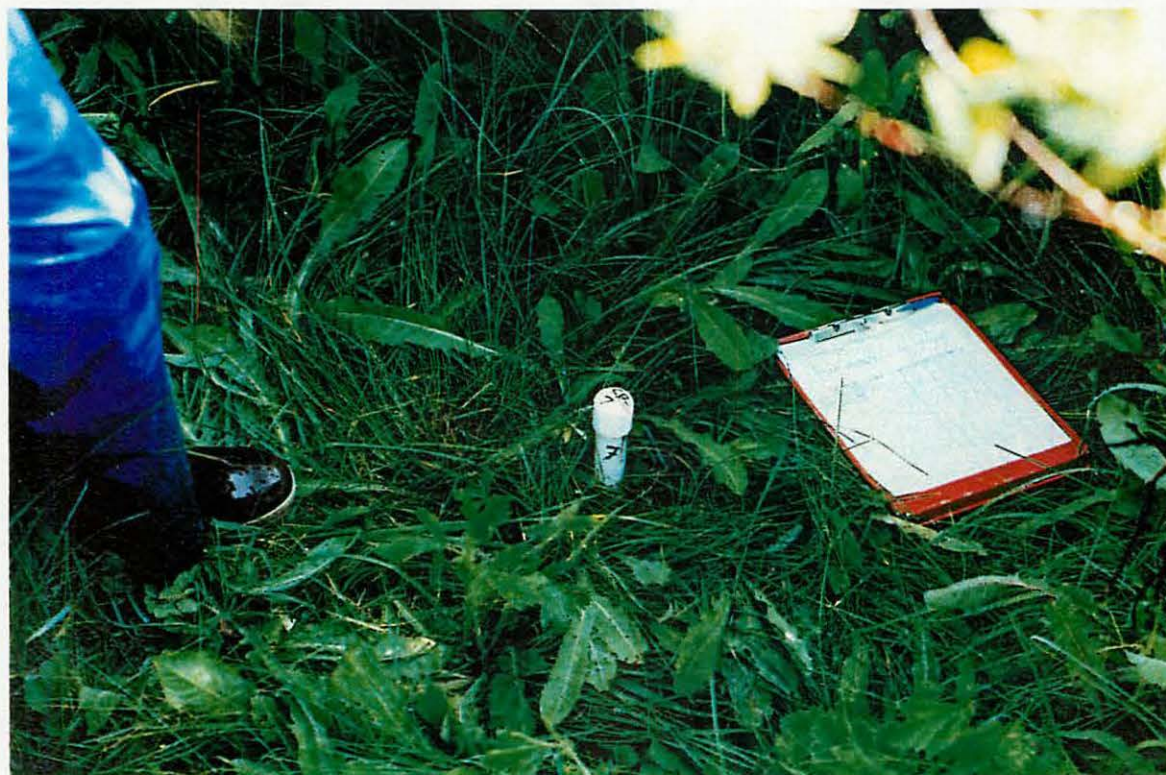
Ground water monitoring well number 7

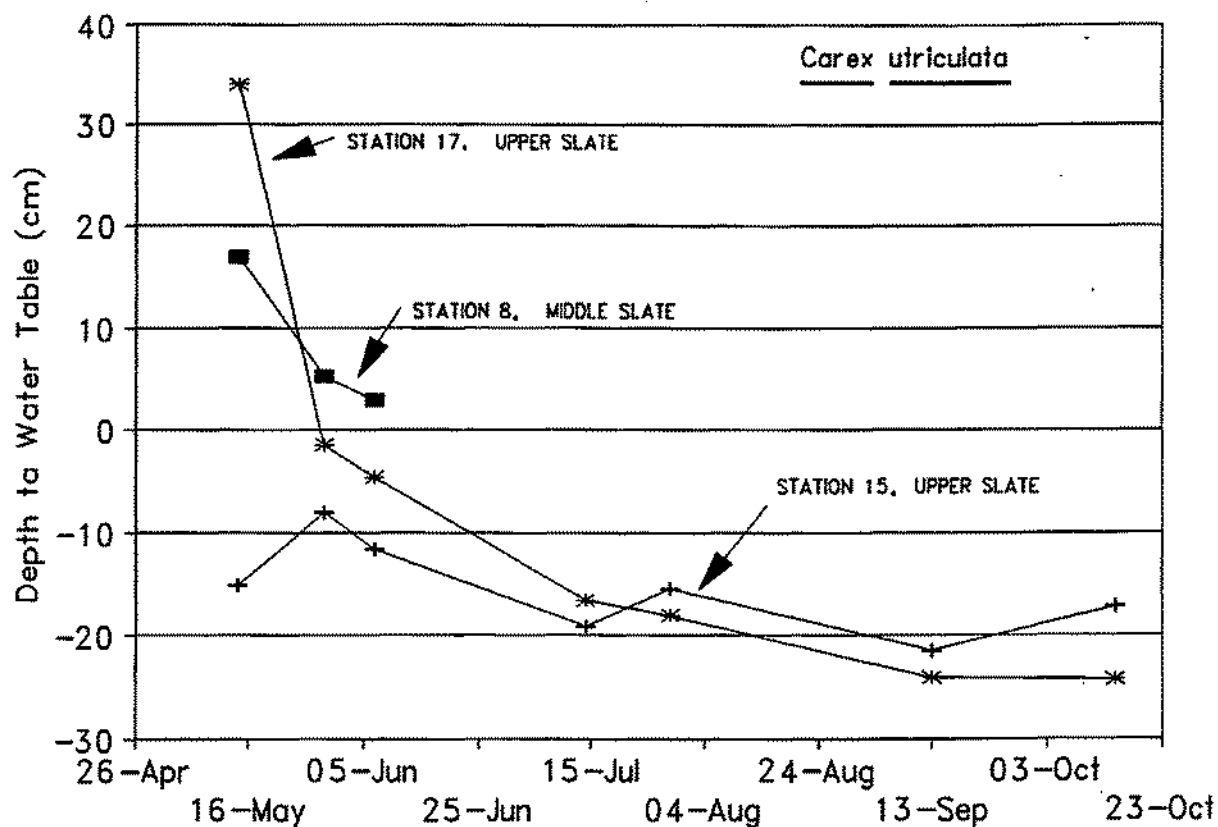
Figure 12. Hydrographs for *Carex utriculata* stands in the study area.

21. *Carex utriculata* (beaked sedge) forms near monocultures in sites with seasonal standing water up to 40 cm deep. These sites can be permanent lake margins (such as around Peanut Lake) and also at large spring systems. It is a very common and important community type in the study area providing important nesting and feeding habitat for snipe and wilson's phalarope as well as many species of ducks and teal. This species can form deep peat soil.
